Manhole Inspection Summary

Manhole # S37C__022MH

Insp Date: **3/26/09 1:35 PM**

Location Address: **CITY IMPOUND LOT @ FALLSWAY** Cross Street: **E PLEASANT ST**

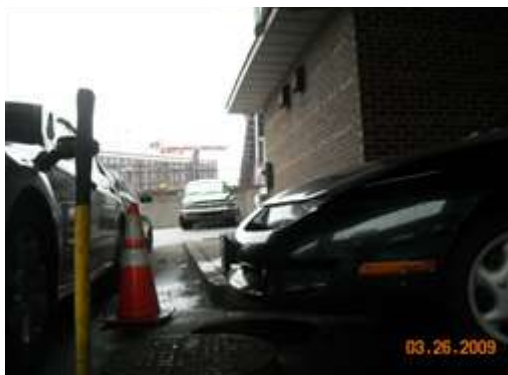
Location View

Comments **CITY IMPOUND LOT, NEXT TO BOOTH; USED 16LB MAUL TO FORCE OPEN; CAR HANGING OVER HALF OF MANHOLE AND IS BOXED IN UNABLE TO BE MOVED;**
